Structural Repair of Aluminum Alloy 7050-T7451 using Cold Spray Repair

Sarah Galyon Dorman
Justin Rausch
Moriah Ausherman
Scott Fawaz

Program Goals and Objectives

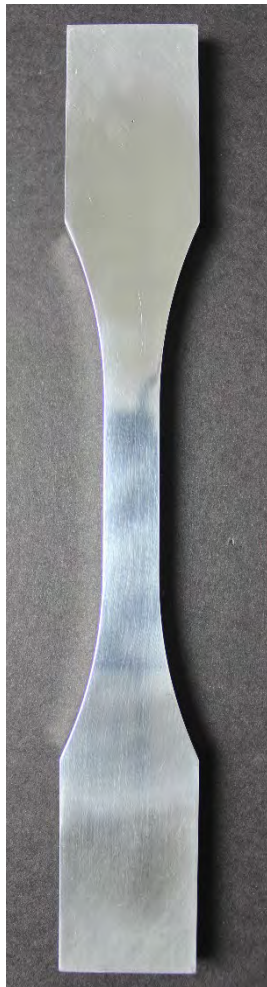
Pristine

15% Blend Geometry

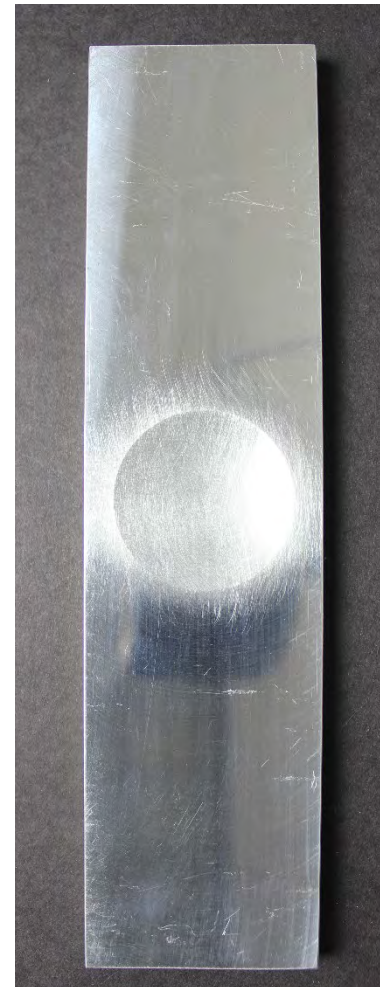
Baseline

30% Blend Geometry

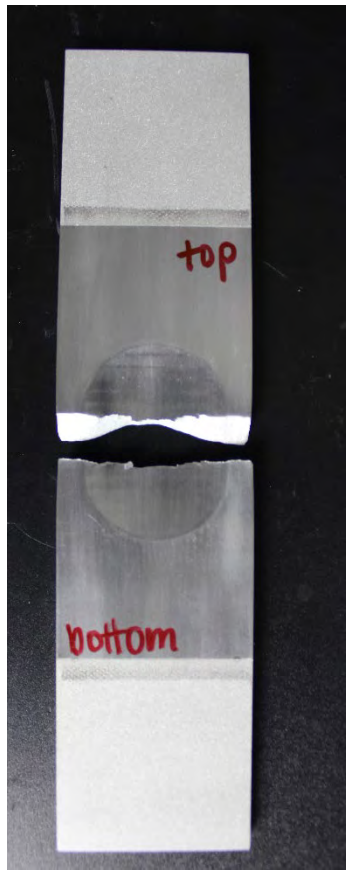
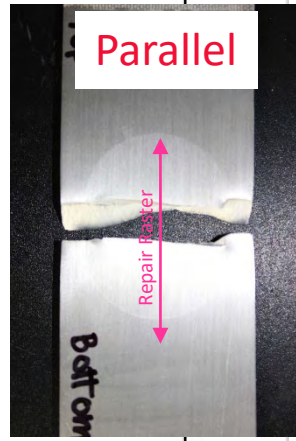
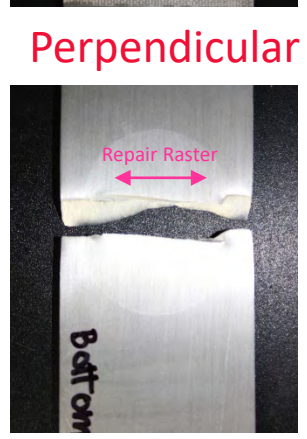
30% Divot Geometry

R = 0.1

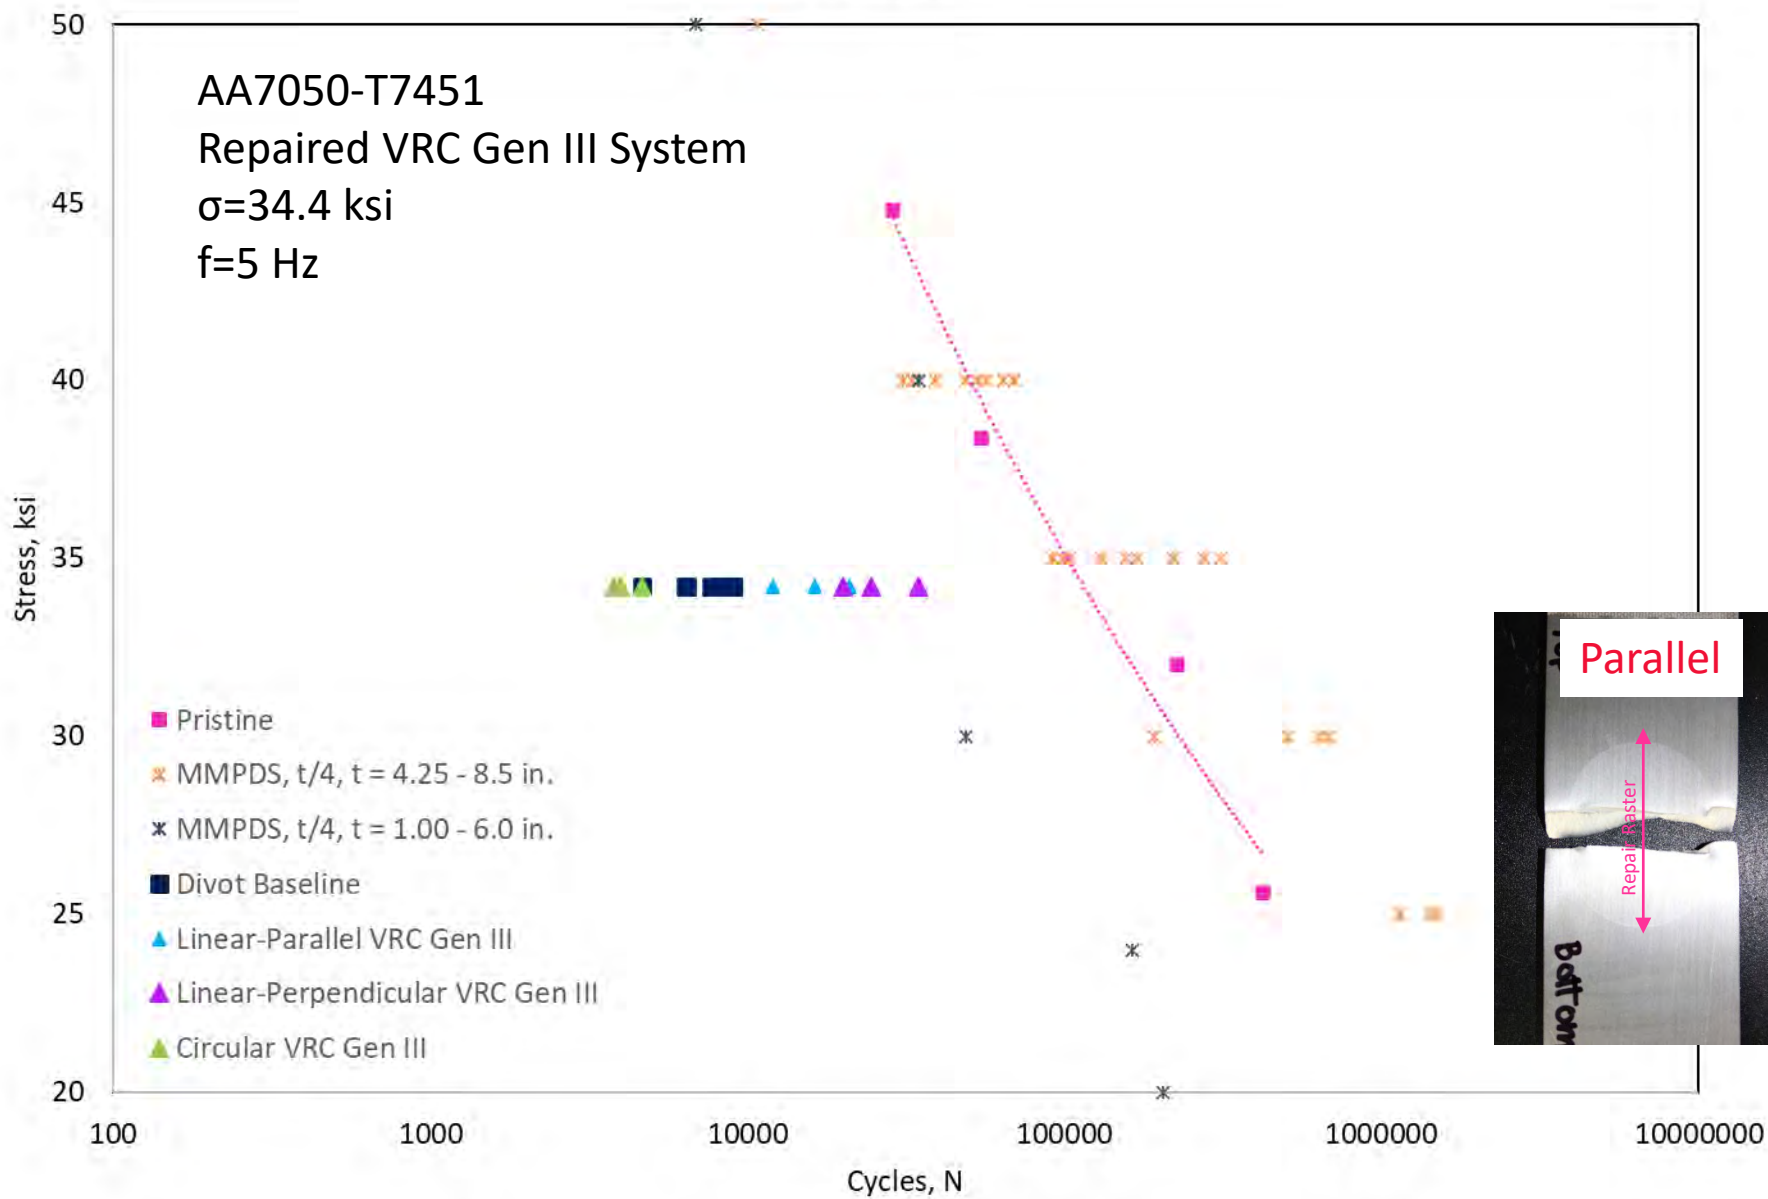
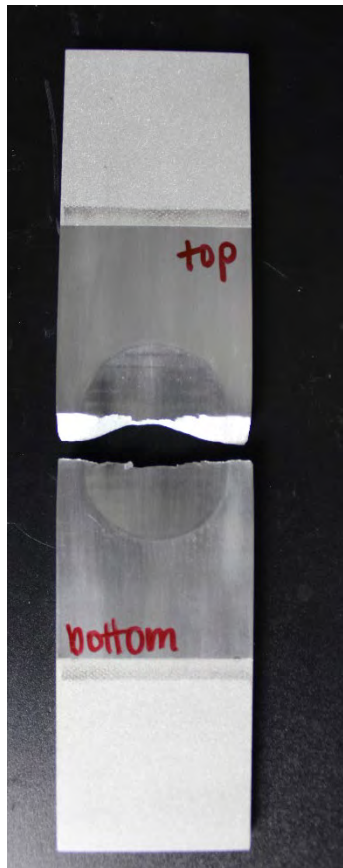
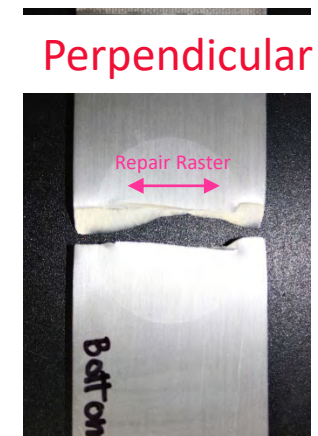
30% Divot Geometry

R = -1.0

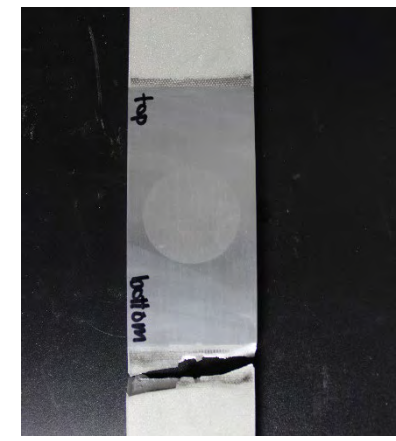
Grip Failure
R= 0.1
N= 38,524 cycles

- In most of the linear-parallel samples, sprayed parallel to the length of the coupon, fracture initiated within the cold spray. No obvious signs of consistent porosity within the cold spray were noted in center cold spray. The correlates with the increased cycles to failure over the baseline.

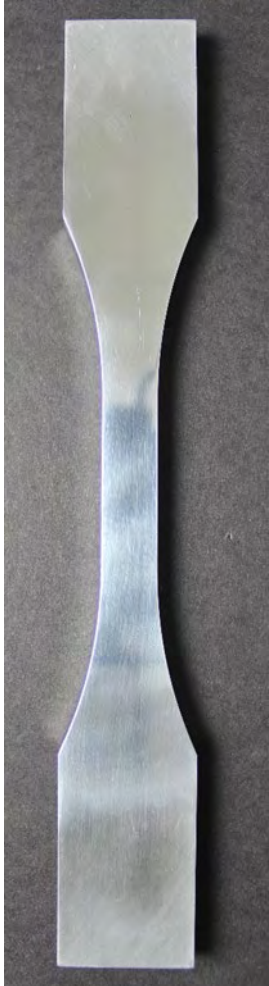
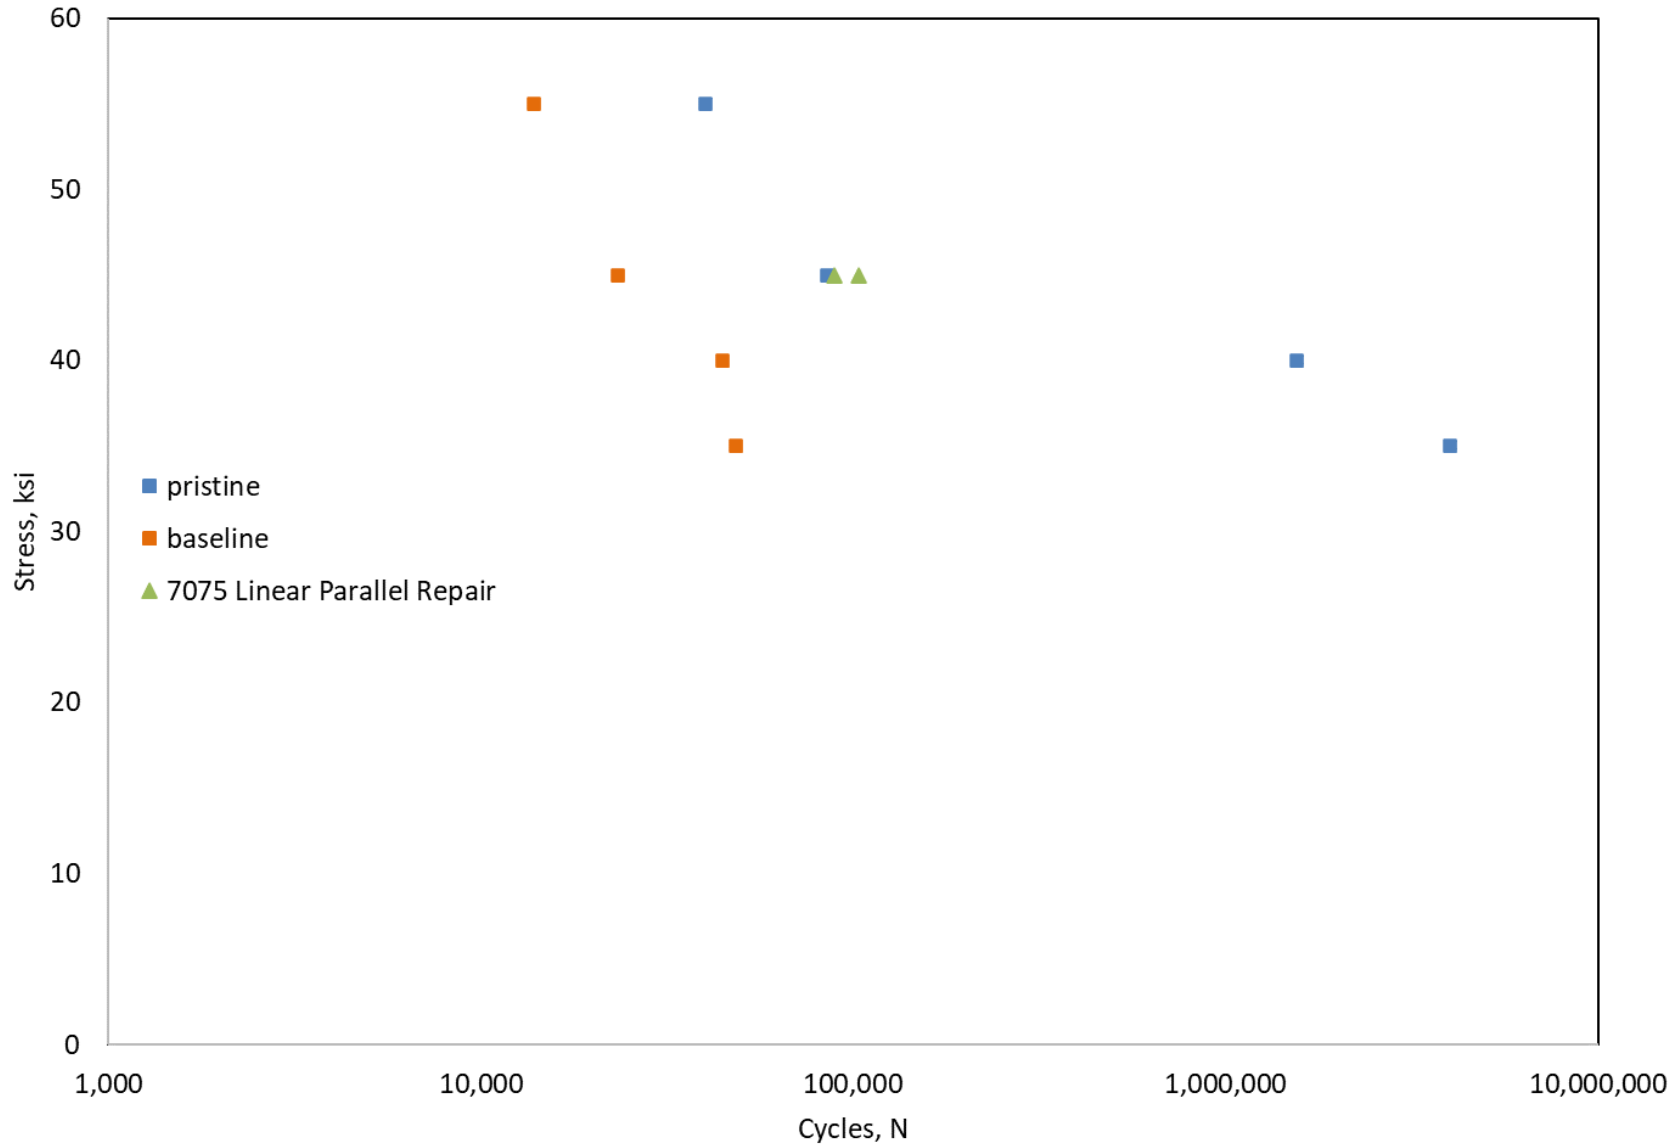
Process Transfer AA7075-T651 (Preliminary Data) 15% Blend Geometry

R = 0.1

- The majority of the fatigue crack initiated within the cold spray and propagated across the interface into the wrought material
- Early fatigue data shows that the AA7050-T7451 process results can be reproduced
